Manhole Inspection Summary

Manhole # S33KK1013MH

Insp Date: **2/28/07 3:11 PM**

Location Address: **4036 GREENWAY**

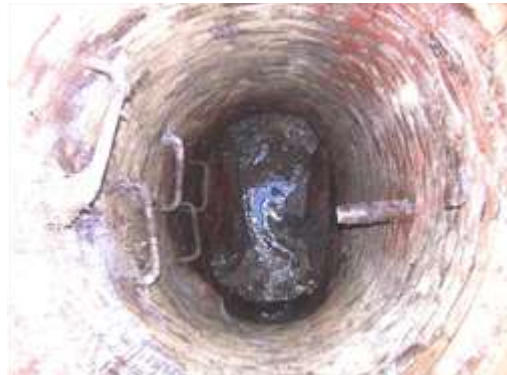
Top View

Frame leaks. Adjustment deterioration and infiltration. Channel debris.

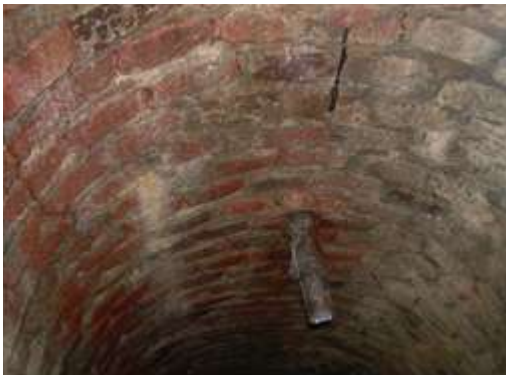
PIPE COMING OUT OF CORBEL

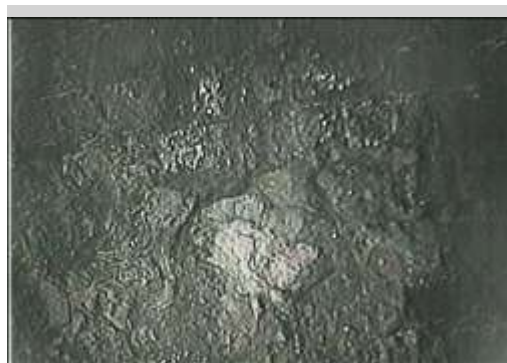
HOLE IN BARREL

Barrel deterioration and infiltration.

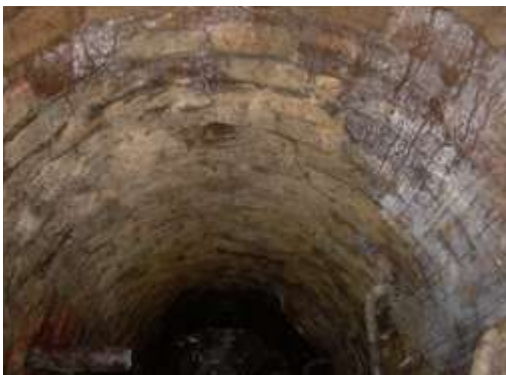
Defect

Adjustment, Corbel, and Barrel infiltration.

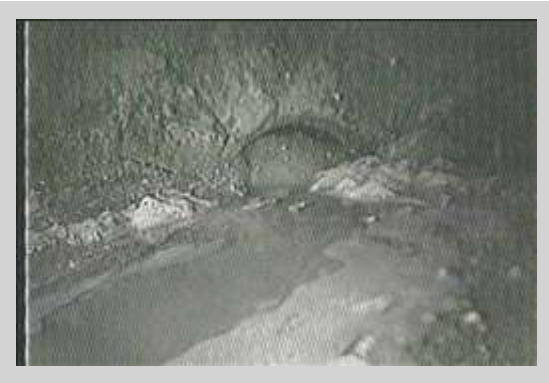
6 in. Circular Gravity Sewer Pipe Out @ 12 O'Clock

Deposits: ☐ None ☐ Mud ☐ Sludge ☒ **Debris** ☐ Grease

Silt Depth: **0** (in.) Deposits Extent: **Medium**

Infiltration: **Evidence** Pipe Seal Cond: **Unknown**

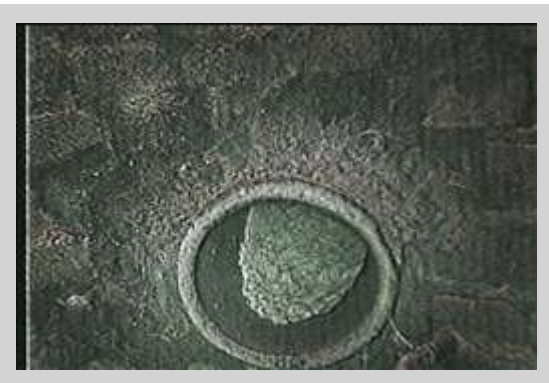
6 in. Circular Gravity Sewer Pipe In @ 8 O'Clock

Deposits: ☐ None ☐ Mud ☐ Sludge ☒ **Debris** ☒ **Grease**

Silt Depth: **0** (in.) Deposits Extent: **Light**

Infiltration: **Evidence** Pipe Seal Cond: **Broken**

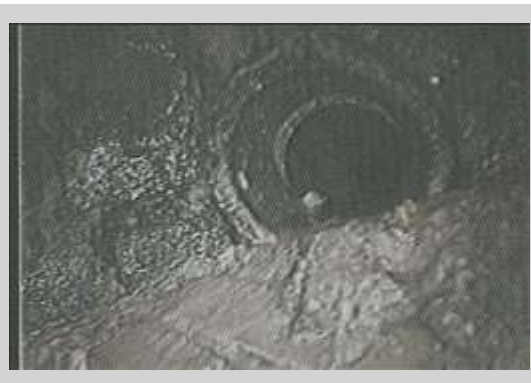
Drop In @ 8 O'Clock

Drop: **Outside** Rod and Bar

Drop Condition: **Open**
